Wear Behaviour and Characteristics of Worn – out Valves used in LPG – run Retrofitted Gasoline Engines

[Pandey Ajay, Mandloi R. K.]

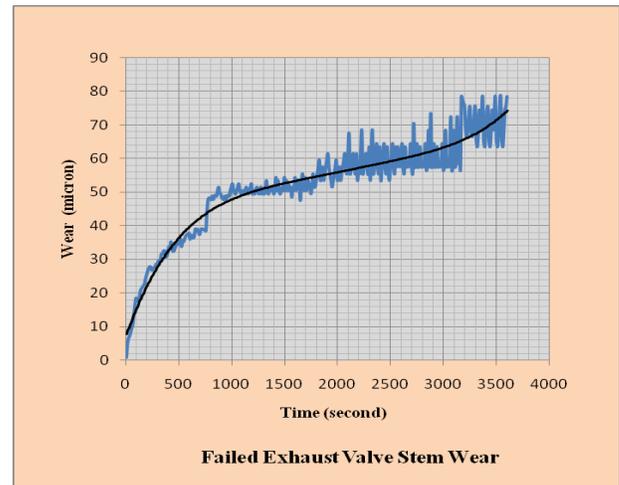
Figure 4 Wear variation curve for a failed exhaust valve stem

For a failed exhaust valve stem, the wear variation pattern is more regular and on predictable lines (Fig. 4). Its magnitude varies from 0.68 microns to 78.41 microns. The wear V/s time curve (Fig. 5) indicates that the stem is relatively softer than the disc and wears out consistently. As shown, wear varies from 0.72 microns (minimum) to 62.69 microns (maximum).

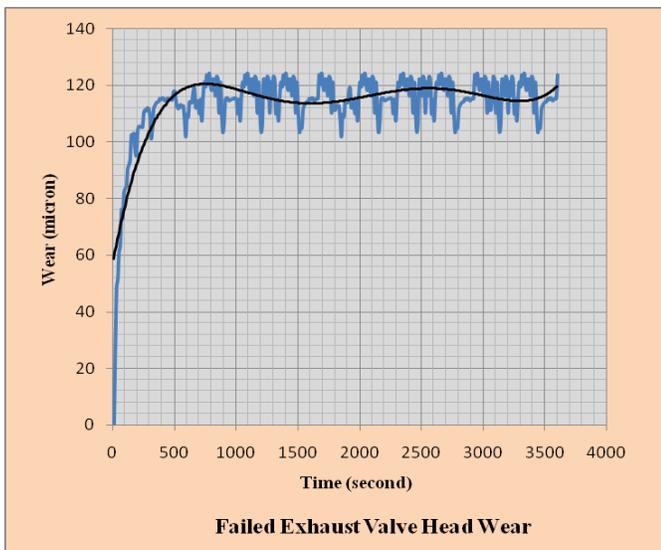
Figure 2 Wear variation curve for a failed exhaust valve head

The variation of wear with respect to time (Fig. 2) for a failed exhaust valve exhibits a definite similarity with oxidative wear mechanism. Corresponding to a particular load, the surface oxidation phenomenon is beneficial as it reduces the depletion of material. This is particularly true at high sliding speeds. The softened oxide film acts typically like a lubricant layer that protects the metallic substrate. The oxide films formed prevent direct metal - to - metal contact and also result in reduction in the coefficient of friction on contact surfaces, thereby reducing adhesive and deformation - controlled wear. The oxidation of material is closely linked to the existing operating temperatures and therefore is on expected lines as the exhaust valve in an LPG - run retrofitted gasoline engine usually encounters high temperature. However, the oxide layers formed on the material surface start wearing off with passage of time. The wear magnitude varies from a pretty low value of 0.39 microns to 124.41 microns as shown (Fig.2). The nature of the curve (Fig. 3) for a new exhaust valve head shows steady state wear after the initial zone of instability. The crests and troughs in this curve may be attributable to presence and sudden appearing of highly abrasive particles that raise or lift the pin on the POD tester, thereby creating sharp changes in wear magnitude. The magnitude of wear varies from a minimum value of 0.24 microns to a maximum value of 6.31 microns as is evident (Fig. 3).

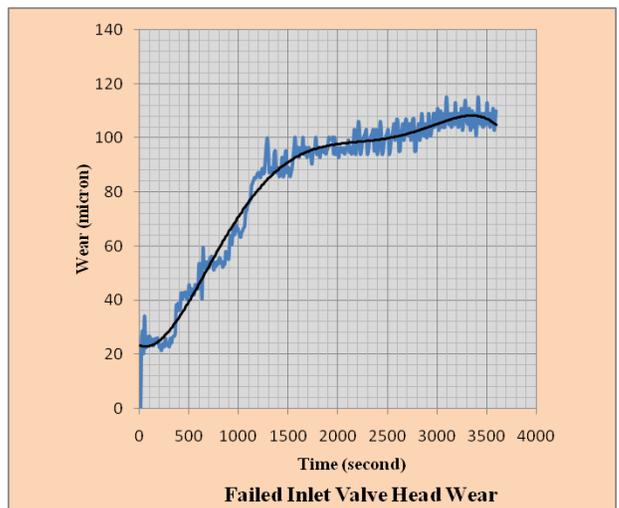
Figure 6 Wear variation curve for a failed inlet valve head

The variation of wear w. r. t. time for a failed inlet valve head is shown in Fig. 6. The variation reflects an almost steady wear condition with no noticeable abnormal behavior across any zone. The corresponding curve for a new inlet valve shown in Fig. 7 exhibits a wear pattern that is quite akin to adhesive wear.

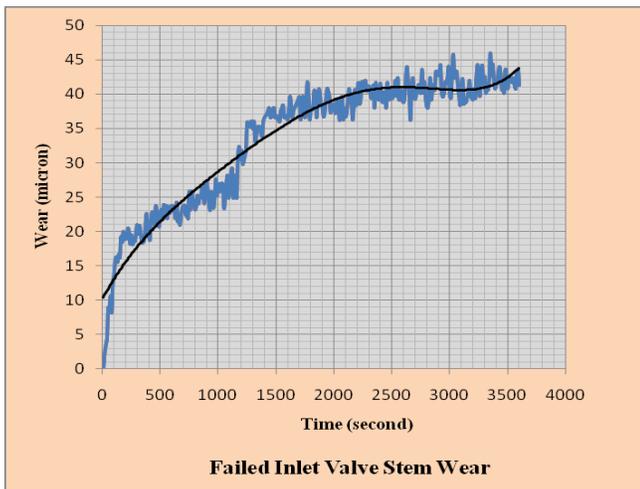
Figure 8 Wear variation curve for a failed inlet valve stem

For a failed inlet valve stem, the variation curve (Fig.8) shows removal of surface films with time and the building up of steady state wear whereas the corresponding one (Fig.9) for a new valve stem is characterized by adhesive wear, presence of surface particles / surface films, and graphite flakes.

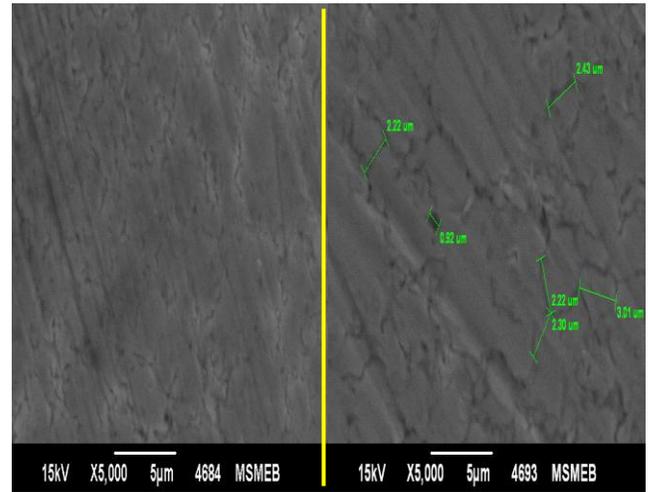
the presence of oxides whereas blackish grey patches indicate the presence of carbides in the valve material as also the effect of corrosion which becomes more pronounced at high temperatures. A fine distribution of carbides indicates increased material hardness but a coarse distribution of carbides makes them shift towards the grain boundaries with an accompanying reduction in the hardness and weakening of the material. The grain boundaries visible in the SEM image indicates that grains are broken and are not uniformly distributed. The size of grains, which is an indication of material strength, increases after working at high temperatures. Big size grains indicate lower strength whereas small size of grains (or finer grain sizes) indicates higher material strength. An increase in the size of the grains, or elongated grains, in SEM images of failed valves indicates that the valve material strength has come down after being subjected to high temperatures for considerable periods.

Figure 10 SEM image of a new exhaust valve head (left) and failed exhaust valve head (right) at X5000

SEM images depicting the microstructure of new & failed intake & exhaust valves are shown at X5000 resolution (Fig. 10 & Fig. 11). The white colour spots in the images indicate

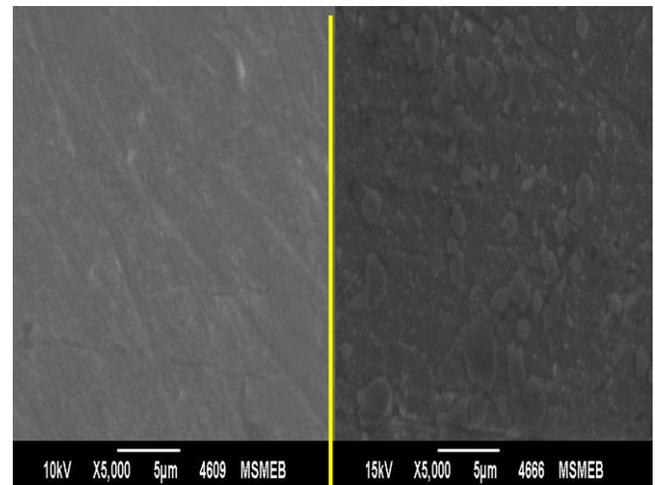
Figure 11 SEM image of a new exhaust valve head (left) and failed exhaust valve head (right) at X5000
