# Potentials of ground penetrating radar for the assessment of outer stone masonry leaves

Charles Bridge in Prague

Jan Válek, Jakub Havlín, Monika Slavíková

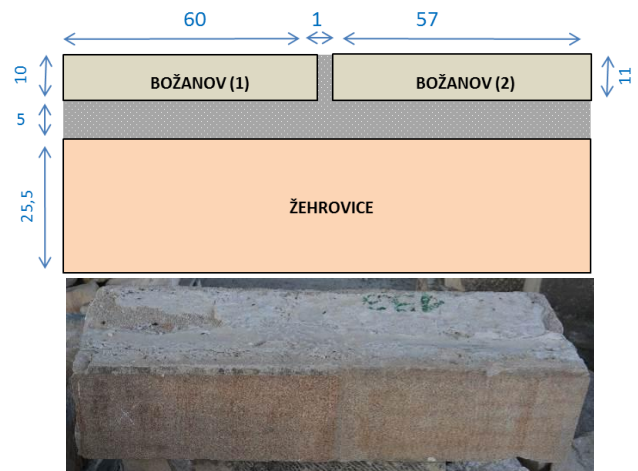
Initially, larger stone masonry blocks which were withdrawn from the bridge during previous repairs were assessed to evaluate the method with a possibility to examine also the inner structure that was partially visible. An example from this initial measurement is given for a stone block No. 133 composed of original Žehrovice sandstone and two replacement stones (Božanov sandstone) cemented with an adhesive mortar, see the drawing on Figure 2. The radargrams are presented on Figure 3. The thickness of the first stone slab is clearly visible and identifiable by the reflected signal from the interface sandstone božanov – cement grouting. However, the next interface grouting – sandstone (Žehrovice) was not identifiable. The last reflection is from the end of the block. However, the cement based grouting attenuated the signal differently along the scan.

Figure 2. Dimensions and photo of the assessed block No. 133

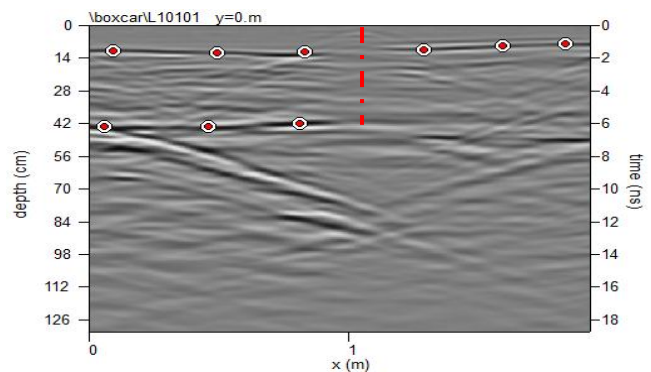
Figure 3. A radargram taken in the middle of the block. The dots mark points at which the depth was determined to calculate precision of such reading. The first layer – facing stone, the second layer – end of block.

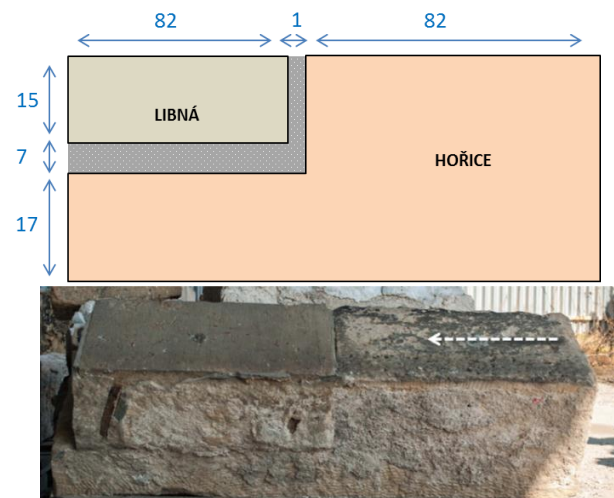
Another example is a block No. 82VA. In this case a decayed part of the original block (Hořice sandstone) was replaced by a new piece of Libná sandstone, see figure 4. The radargram on figure 5 shows reflection at the end of the Hořice sandstone block. However, both Libná sandstone and the cement based grouting caused attenuation of the signal. The interface between the Libná sandstone and the grouting is possible to determine but the reflection is relatively weak. Moreover, there is a reflection artefact on the right hand side which is not accompanied by hyperbolic reflections.

Figure 4. Dimensions and photo of the assessed block No. 82VA. The white arrow is the direction of scan taken.

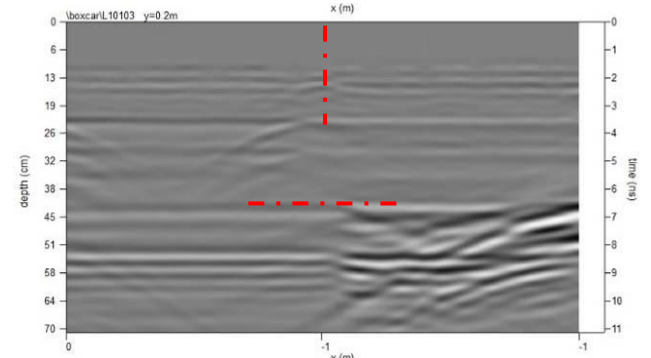
Figure 5. A radargram taken in the middle of the block 82VA.

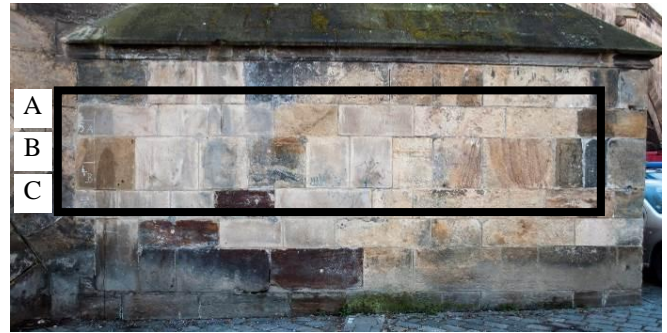
Trial assessment of masonry of the bridge was carried out *in situ* on a pier shown on Fig. 6. The initial setting was kept the same as for the previous measurements on the blocks. The whole area was assessed by horizontal scans taken in longitudinal direction 5 cm apart. Only typical scans are presented below to demonstrate the measurement outputs. There were 5 other similar sized areas assessed *in situ* on the bridge.

Figure 6. Trial assessment carried out in situ on three layers of sandstone masonry marked by the square.

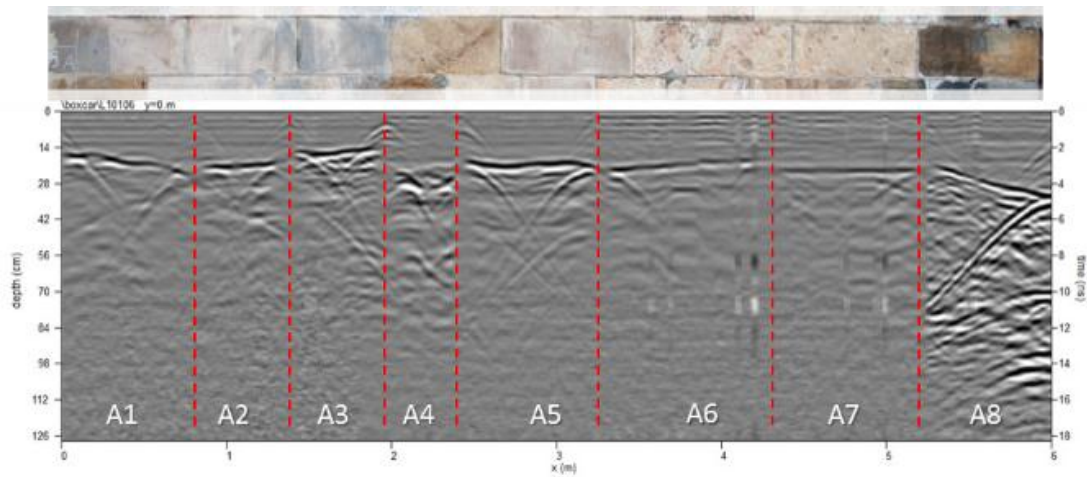
Figure 7. A representative GPR scan of the masonry layer A.

A typical scan representing the assessment of the masonry layer marked A is presented on Fig. 7. In this case the GPR assessment identified well the thickness of the stone units. The depth of the reflection from the end of stone interface is about 15-20 cm and it suggests that these stone units are only facing stones that replaced the larger (deeper) historic ones. All of them are probably well connected with the masonry behind and there is no reflection that would suggest the ends of original stone blocks. This is probably due to the attenuation of the grouting mortar behind the blocks. Potentially less well bonded are stone units marked as A3, 4 and 5. However, there is no larger void producing a repetitive reflection of the signal. The corner stone A8 does not have a rectangle shape and its rear side is widening towards the corner. The shape of the reflection corresponds to the rear side. This means that units A6 and 7 are relatively regularly cut blocks as opposite to e.g. unit A1 and A4 with rather rough rear surface.

facing stone							stone
Depth [cm]	15-17	19-18	13-14	22	17-18	18-19	20	20-30

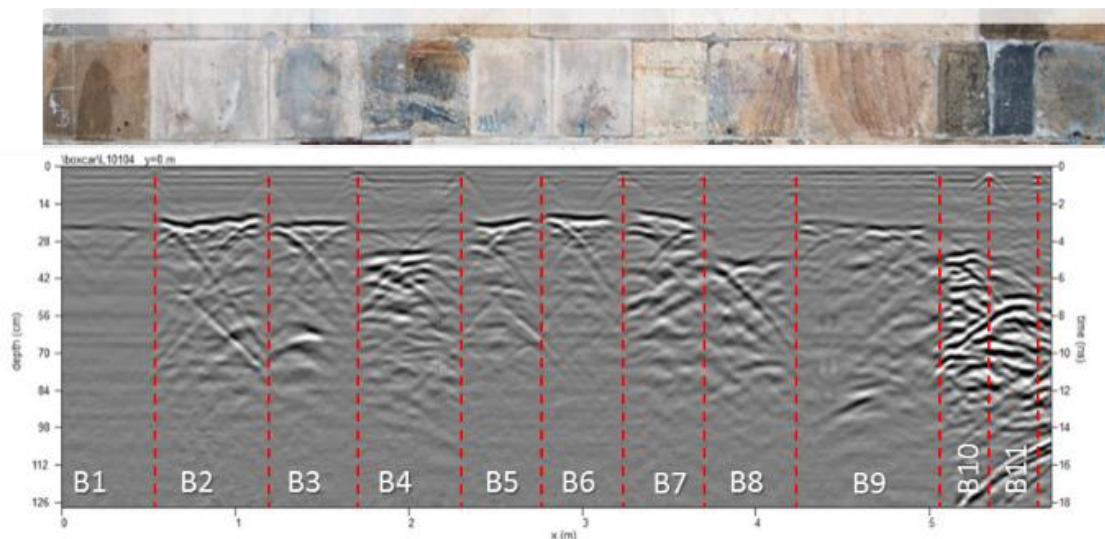
Figure 8. A representative GPR scan of the masonry layer B.

The GPR assessment of masonry layer B is presented on Fig. 8. Similarly to the layer above (A) there are reflections at the depth of 15-20 cm which is attributed to newer facing stones. Original stone depth is assumed to be around 30 cm (B4 and B8) with occasional larger bonding stones. Stone unite B1 caused exceptionally high attenuation of the signal. Deeper reflections are not forming any clear pattern to allow interpretation regarding the structural morphology of the masonry.

They could be associated with a certain inhomogeneities of masonry like larger stone blocks (B2, 3, 8 have reflections around 60-75 cm) or possibly also metallic objects (B11 – hyperbolic reflection). Irregular reflections behind the blocks B4, 7 and 8 suggests rubble stone masonry. The reflections near the corner can be interpreted as irregular inhomogeneous rubble masonry.

facing stone		stone	facing stone			stone	facing stone	stone		
Depth [cm]	18	16-18	18	30	18-19	16	15-17	31	18-20	30	46

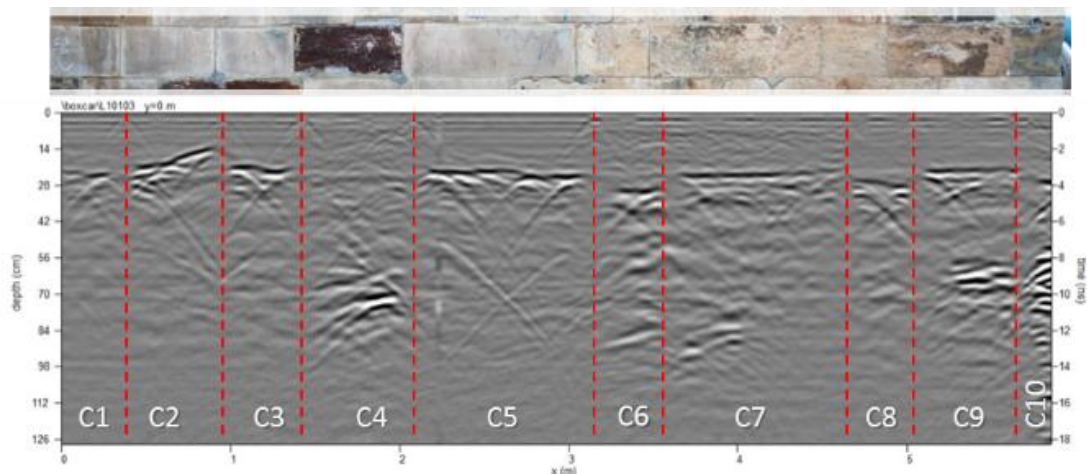
Figure 9. A representative GPR scan of the masonry layer C.

A typical scan representing the assessment of the layer C is presented on Fig. 9. The reflections at the depth of 15-20 cm are attributed to the replaced facing stones. Unit C4 is probably one of the remaining older blocks that reaches the depth of 60 cm. Reflection at this depth is also noted for stone unite C9. The hyperbolic reflections behind the block C5 can be interpreted as several stone units (perhaps the joints of the historic masonry blocks) or possibly also metallic objects.

facing stone		stone	facing stone			facing stone		
Depth [cm]	22	12-19	18-20	60-61	21-22	29	21	24-26	20
