International Journal of Civil and Structural Engineering– IJCSE Volume 3 : Issue 1 [ISSN : 2372-3971]

Analysis of errors in restoration of salty and damp walls

Wacław Brachaczek, Cezariusz Magott

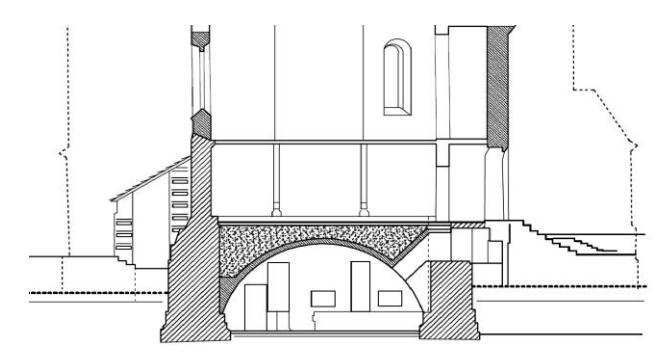
historical analysis - specifying, on the basis of preserved documents, how the building was built and the type of its foundation. In historic buildings the contour of foundations is most often not distinctly separated. The preserved design documents most often, the outline of the basement wall thickness is shown, and you can rarely see strip footing with offset pr expanding linearly obliquely towards the bottom edge of the foundation. In some buildings indirect foundation on stakes or wooden grids are dominant. Their occurrence determines the possibility of surface or band drainage around the object.

Figure 1. Cross section of a medieval stone church in Wroclaw (Poland), different shape and contour of the foundation in relation to the main body of the church is visible.

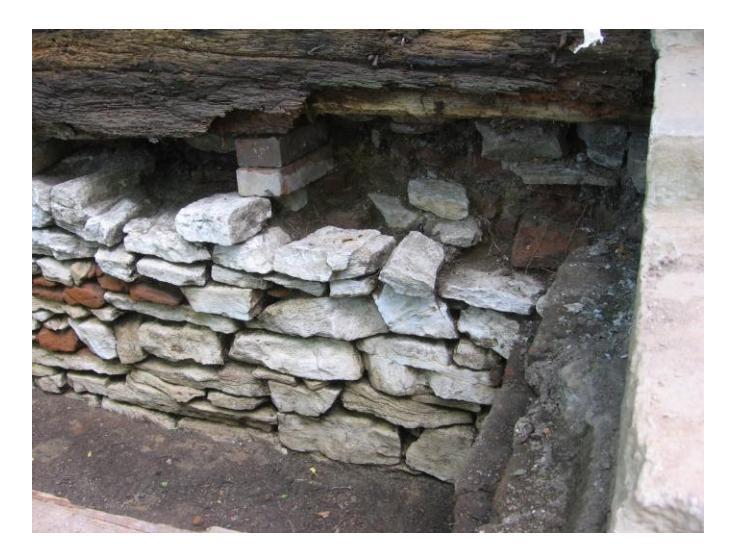
determination of the wall structure - an element necessary to examine the structure of the walls is performing drillings at different heights. In the past, brick was a relatively expensive material, far more expensive than it is now. The consequence was building 'beggar' walls in which the stem was made of less expensive materials. Bricks were only used for the facing wall layer. In the walls of historic buildings the very method of their construction, the type of material, and many centuries of effort caused the development of a variety of irregular voids, caverns and stretch marks. Test drillings may confirm the necessity of initial injections e.g. of low-shrinkage trass mortars in the divisions. This is the basic condition (both for pressure and non-pressure injection) for properly restoring the horizontal diaphragms. Low-pressure injections within the walls with voids result in a given standardized amount of injected product not filling properly the injection holes.

Figure 2. Appearance of the exposed foundation walls of different construction.

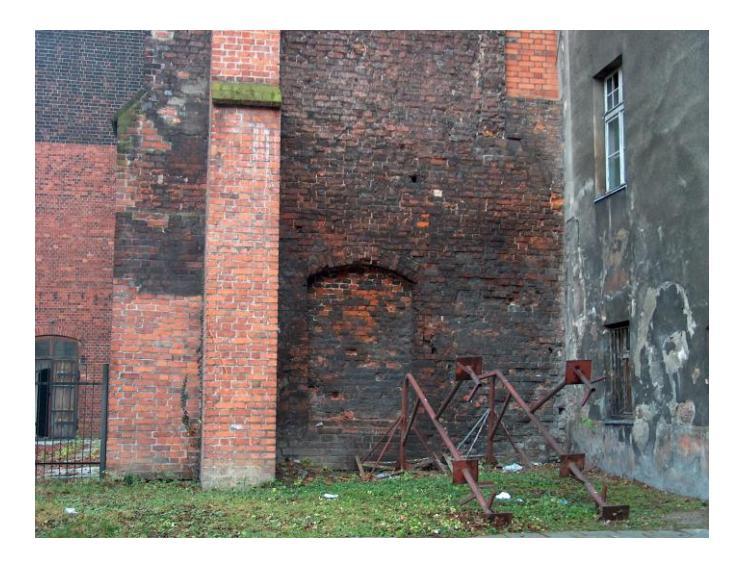
Fig. 3. Moisture level of the northern wall reaches approx. 5 m high above ground level - Museum in Raciborz.

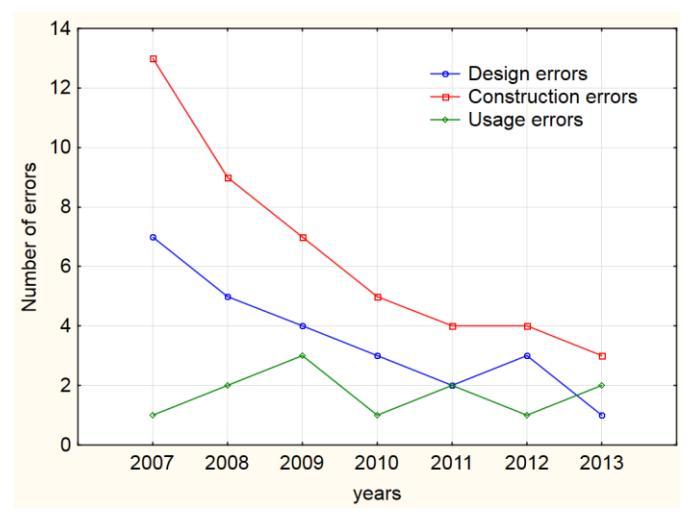
Figure 4. Graphical presentation of errors in the restoration of damp walls in the years from 2007 to 2012.

Analyzing the chart in Figure 4 we can say that with as years go by the dynamics of design and construction errors decreases. Particular intensification of errors was observed in the years from 2007 to 2010. In subsequent years the number of errors is lower and lower. This shows an increase in technical awareness among both the designers and contractors. Knowledge and experience gained by the technical and engineering staff results in reduced number of restoration errors.

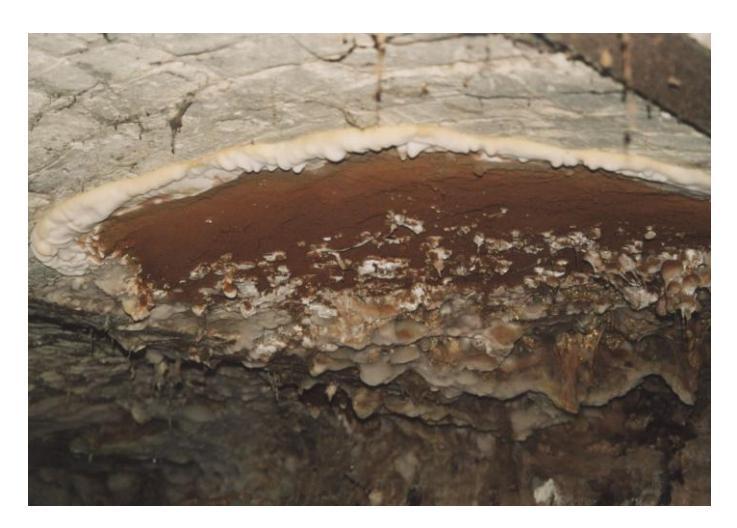
led to the need for further renovations. In another case, after renovation, the owner of the building carried out further repairs involving the replacement of electrical installation. Grooves carved in renovating plasters were filled with gypsum mortar. After re-painting the walls, the whole installation layout was visible. A common mistake of the owners was also poor care for sufficient ventilation of rooms. In many cases, the air grates were veiled or blocked with furniture. Consequently, this has led to the emergence of the house or moldy fungus [12].

Fig. 5. The fruiting body of the house fungus proper (Serpulla lacrymans), grown into a vaulted ceiling of a basement room
