Superficial Layer Landslide Deformation Features in northern part of Lesser Khingan Region, China

Wei Shan, Zhaoguang Hu

Abstract—In recent years, permafrost in the northeast of China is being severely degraded. Bei'an-Heihe Expressway crosses northwest part of the Lesser Khingan Range region. The landslide is located in an area of the island's permafrost. Due to atmospheric precipitation, the presence of permafrost, regional climate conditions, and special geological conditions, landslides occur annually from late May to early November. The area is in a relatively stable state during winter. These seasonal landslides have seasonal, gradual, low angle characteristics. By January 2014, the landslide had moved a distance of up to 113.32 m (in the rear), and 26.4 m (at the leading edge). With cumulose soil at rear of landslide decreasing, and the recorded movement of the landslide over time, the landslide deformation appears to show an apparent attenuation trend. This article combines a geological survey and over three years of monitoring surface deformation. Research results show that: water infiltration of rainfall, melting snow and permafrost melting is stopped by frozen soil and

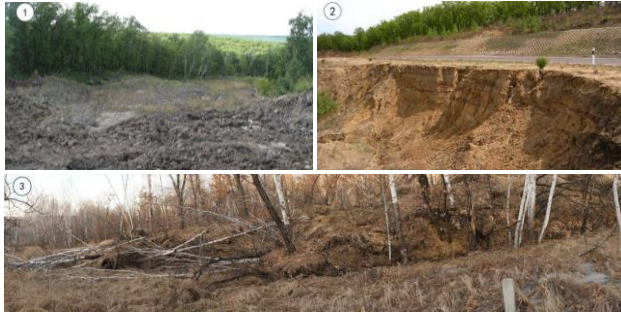
The landslide scene photos are shown in Fig. 1. The landslide is located on the left-hand side of the road embankment. Road abandon soil and subgrade filling soil slide along the gully. The 178+530 landslide presents a tongue shape, and its width is 20–30 m, its acreage is about 5000 m²,

the distance from toe to rear edge is about 200 m, the elevation of toe is 254 m, and the elevation of rear edge is 285 m. The leading edge of the landslide pushes up humus soil of the original ground surface, which consequently slides forward. The arcuate dislocation in the rear edge was in the range of the wider subgrade. There, the trees tilt at the leading edge of the landslide.

Figure 1. Landslide scene photos: 1) Panoramic view of landslide; 2) The trailing edge of landslide; 3) The leading edge of landslide

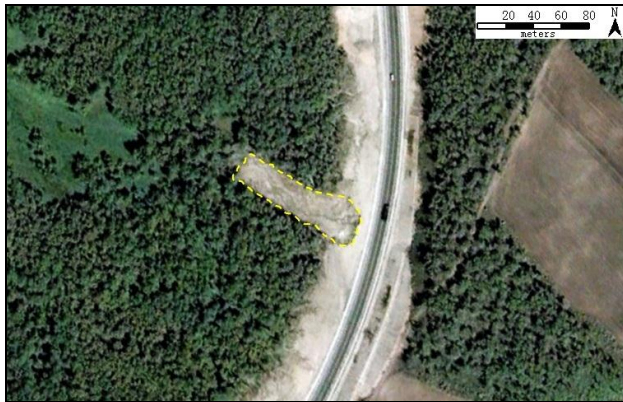
K178+530 landslide external form is rendered as a band, with the formation and development of the landslide, apparent form of landslide is constantly changing, slide range is gradually increasing. As shown in Fig. 11 for the October 2010 landslide image, landslide area is 1.5 times of the 2004 landslide area (in Fig. 10), landslide occurred greater deformation in recent years.

Figure 10. The 2004 landslide area (Google image)

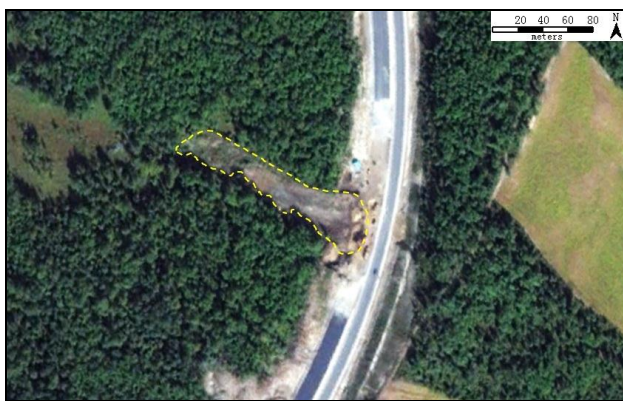
Figure 11. The October 2010 landslide area (Google image)
