Review and a validation project on delayed Ettringite degradation during mass concreting

K S Ang, Z H Chew, S C Fan*

School of Civil & Environmental Engineering
Nanyang Technological University, Singapore

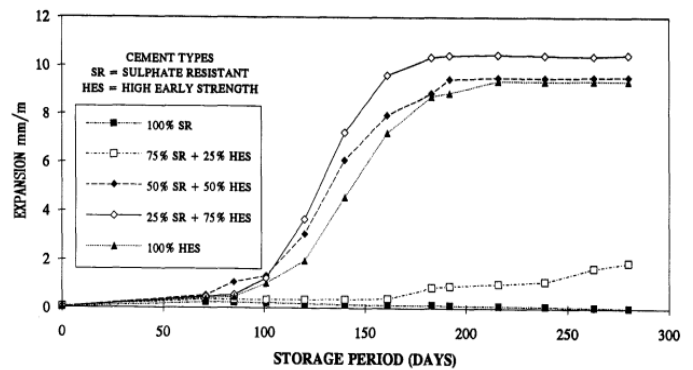
Figure 1: Examples of Various Mortars after Heat Treatment (Ghorab et al. [8])

In a second series of experiments, specimens were subjected to a 1-day delay period followed by 1.5 days at 80°C and then a 6-hour temperature rise to 100°C; immediate cooling then followed, causing the specimens to reach maximum temperature. Fig. 1 shows the expansion of bars which were manufactured based on different blends of sulphate-resistant (SR) and high-early-strength (HES) cements. Blends which contained more than 25% high-early-strength cement have shown substantial expansions which starts after soaking in water for 70 days.

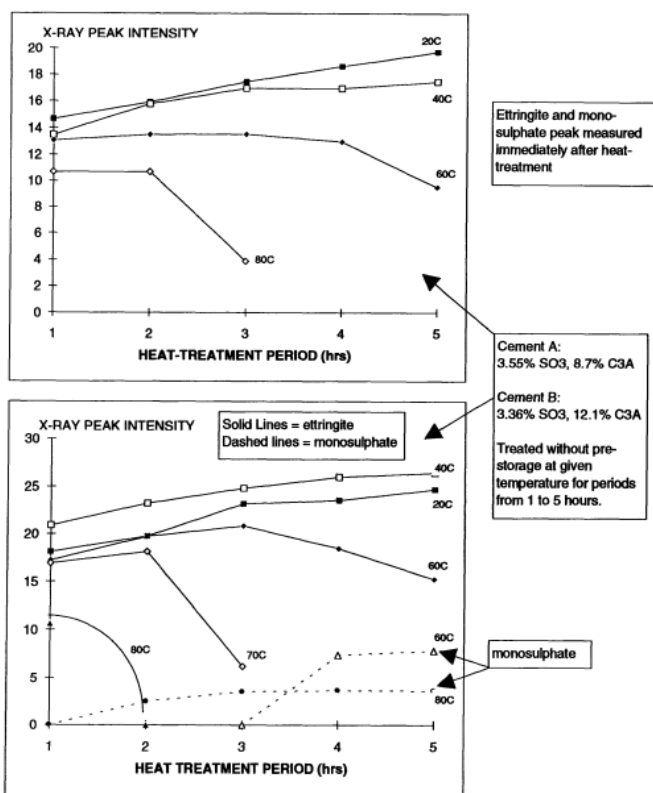
Figure 2: Variation in X-Ray Peak Intensity with Curing Temperature (Sylla [9])

In 1988, Sylla [9] noticed that as the temperature increases in concrete, both the reactivity and speed of dissolution of tricalcium aluminate (C₃A) increases, while the available sulphate in solution decreases concurrently. This causes an increased tendency to form monosulphate rather than Ettringite. The importance of the treatment temperature and heat treatment period on the quantity of Ettringite present are shown in Fig. 2. Results are based on cement pastes made with two different types of cements. Both cements had approximately the same sulphate content but cement B has 12.1% C₃A while cement A had 8.7% C₃A. The extra aluminate in cement B results in monosulphate forming in some pastes when treated at 60 and 80°C. The high C₃A cement also shows a more rapid reduction in Ettringite content.

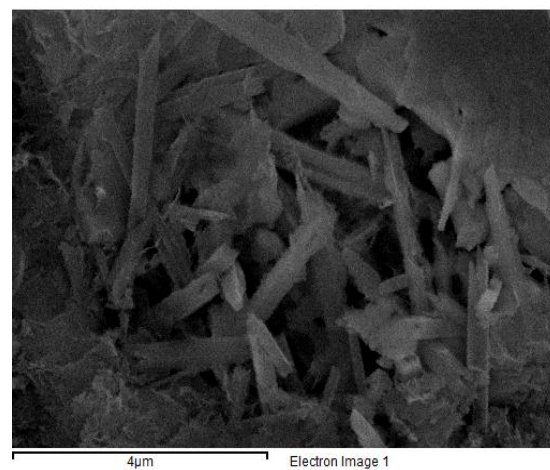
Figure 5: FESEM Image at 30,000X, Spatial Resolution of 50 to 100 nm of a Specimen from Core Sample (Labelled 2.1-2)

By utilizing the Field Emission Scanning Electron Microscope (FESEM), high resolution micro-structure images were observed and captured at high magnification. In it, a field-emission cathode from an electron gun provides narrow probing beams at both low and high electron energy producing a less electrostatically distorted and sharper images with spatial resolution down to 1.5 nm. It will make the identification of Type-1 and Type-2 Ettringite if present, possible. Fig. 5 shows an image capturing the needle-shaped Type-2 Ettringite crystal in a specimen of core sample (labelled 2.1-2)

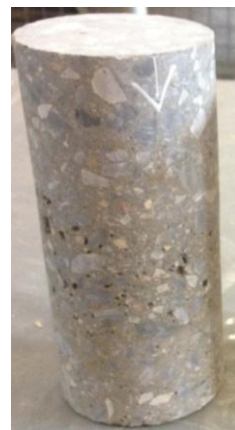
Figure 9: Cylindrical Sample

Compressive strength test was carried to investigate whether there is degradation in strength in association of the presence of Ettringite formation. The sample size is 100 mm in diameter and 200 mm high as shown in Fig. 9. The moment at failure is captured in Fig. 10, and the crushed sample is shown in Fig. 11. The compressive strength of 39.6 N/mm² for a specimen from core sample (labelled 2.1-2) was registered.

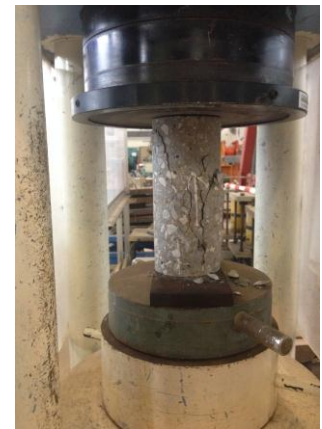
Figure 10: Compressive Test

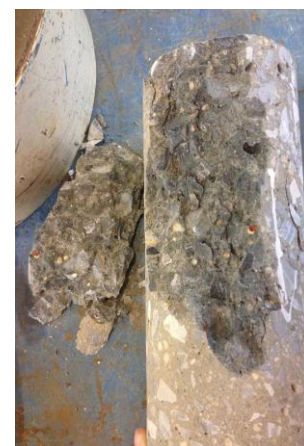
Figure 11: Crashed Sample

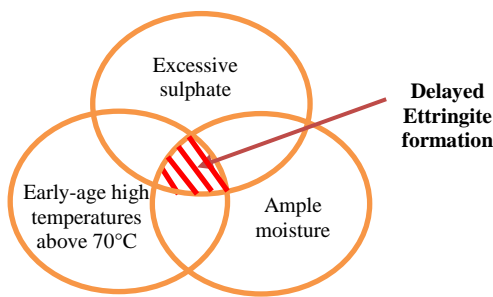
Figure 12: Essential Conditions for DEF

harmful as its volumetric expansion would lead to deterioration in the hardened concrete [13]. However, the cited temperature conditions for harmful expansion of DEF is necessary but not sufficient, although laboratory data support that deleterious expansions have not been observed at 70°C or less, regardless of cement characteristics [14]. Besides the necessarily higher early-age temperatures above 70°C, the sufficient conditions for DEF requires the presence of other substances, essentially ample moisture and excessive sulphate as illustrated in Fig. 12.
