Thaumasite Formation in a Newly Built Concrete Structure in Northeastern Algeria

[TOULOU M Naïma & BRARA Ahmed]

Abstract: Severe damages such as expansion, cracking, spalling, have been observed in a public facility (communal library) recently built in the northeastern region of Algeria. Microstructural examination of the concrete samples extracted from different structural elements revealed an abundant presence of thaumasite in association with ettringite and/or gypsum. The thaumasite was found within cavities at the interfaces aggregates/cement as well as in the high dolomitic cement matrix. The deterioration of the concrete studied was attributed to the thaumasite sulphate attack (TSA) supported by the alkali dolomite reaction (ADR). With regard to the semi-arid nature of Algerian climate, it appears that the condition of low temperature (less than 5 °C) required for the formation of thaumasite reported in the literature seems to be not necessarily true.

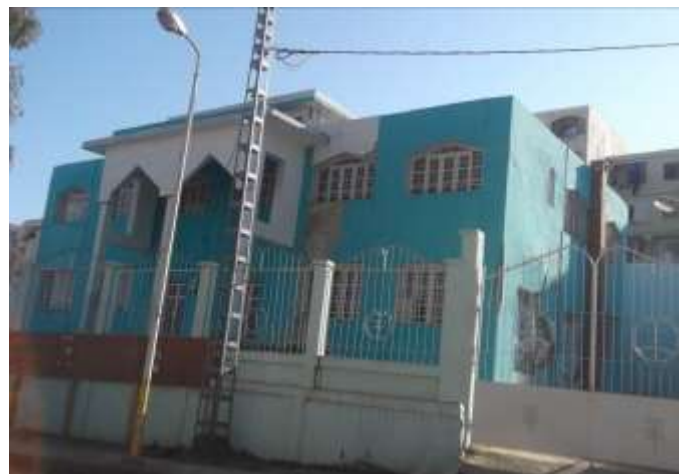
The damaged building investigated was a public facility (communal library) constructed using reinforced concrete, Fig 1. This structure was built during the period 2005-2007 in an important urban area, located in north eastern part of Algeria.

Fig. 1. Damaged public facility in northeastern of Algeria,

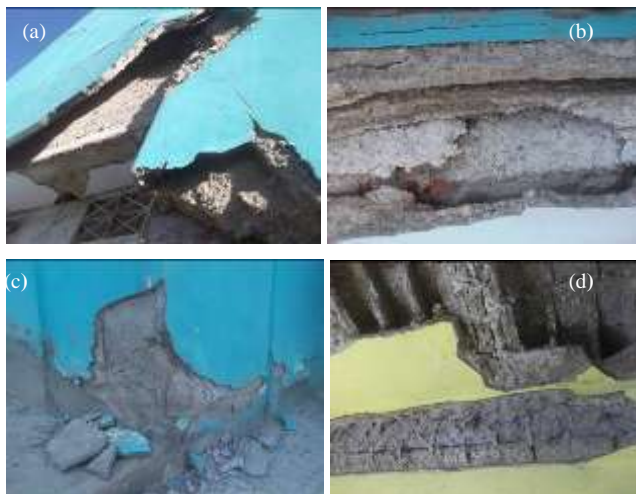
The visual observation conducted revealed various damages such as expansion, cracks, spalling etc., affecting the concrete and mortar, as shown by the Fig. 3 (a, b, c and d) below. These damages include sub-parallel cracks filled with white haloes occurring around aggregate pieces and sometimes cement paste matrix transformed into a mush. The observed damage phenomena have attributed to the sulfate attack associated with the alkali dolomite reaction.

Fig. 3. Damages observed in situ: a) cracks and large expansion of mortar; b) concrete spalling with white coating; c) expansion of concrete and materials loss; d) concrete transformed into mush
