A model for the reuse of disused tanneries

A case-study for the definition of the intervention criteria

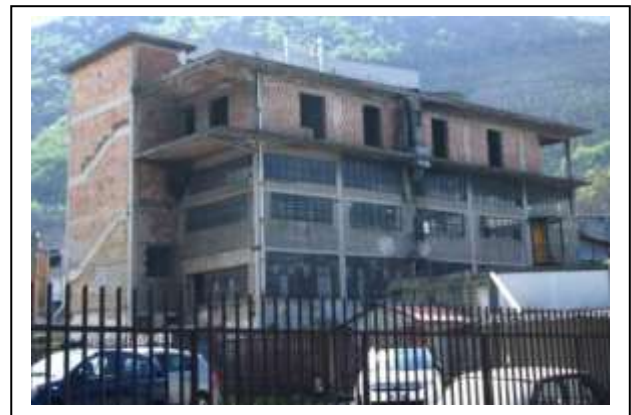
Figure 6. The abandoned tannery

Built in 1979, the tannery has a reinforced concrete framework and trapezoidal layout; the longer side measures 26.50 m, the shorter side 14.00 m. The building has three floors; the roof stands 13.60 m above ground (fig. 6).

The ground floor has three entrances and is divided into two large spaces with 5 m ceilings; yellow tuff blocks are used as infill in the outer walls; the simple glass and iron door and window frames stretch from one pilaster to another around the whole building.

A single staircase on the short side of the building leads to the first floor; the external first floor walls are made of hollow concrete blocks; the height inside is 5.00 m; there are two rows of ribbon windows at different levels from the floor, one at a height of 1.20 m above ground and another at 1.80 m. These windows run all around the building.

The second floor was never finished: there are no window or door frames; the external walls with a double hollow brick lining and air cavity are missing in many parts of the building; the ceiling is 3.00 metres high and the roof is flat.

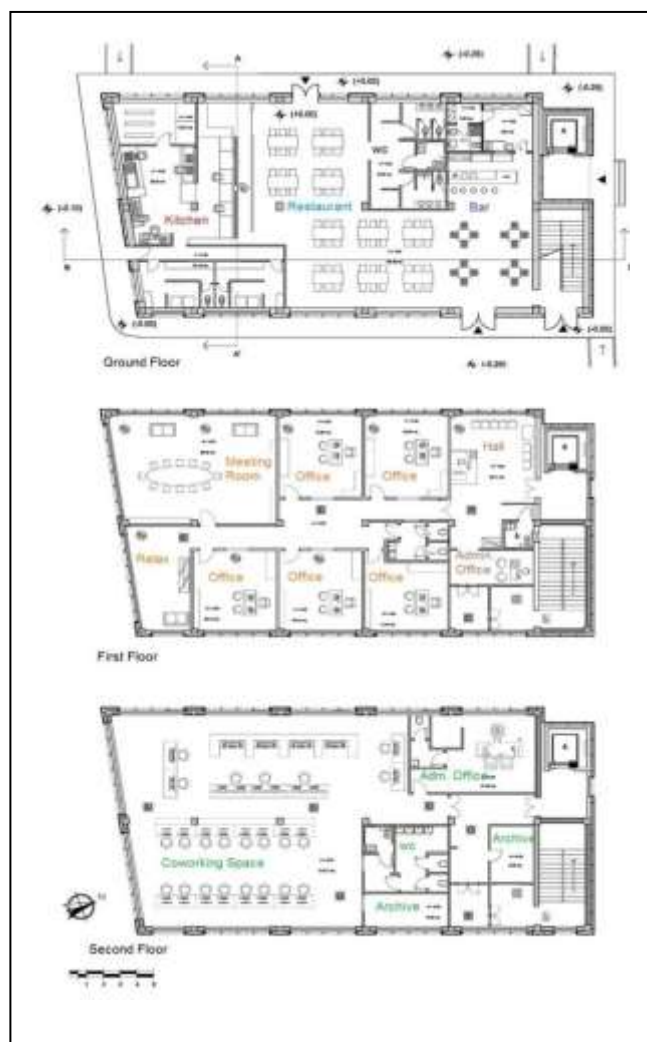
Figure 7. Possible reuse of the former tannery: plan with new uses.

As part of the general requalification project illustrated earlier, and after critical assessment of the indicators of transformability described in paragraph III), the former tannery proved to be a good candidate for conversion to tertiary activities. In particular, it could be used as a restaurant on the ground floor and offices on the other floors (fig. 7). Before the building can be used for these purposes checks must be run to see whether it complies with the main technical regulations in force in Italy.[15, 16, 17, 18, 19, 20, 21]
