Behavior of Screen-Grid Insulated Concrete Forms (ICF) Reinforced Concrete Walls Under Seismic Loads

[Yosra H. El Maghraby, Ezzat Fahmy, Mohamed N. Abdel Mooty]

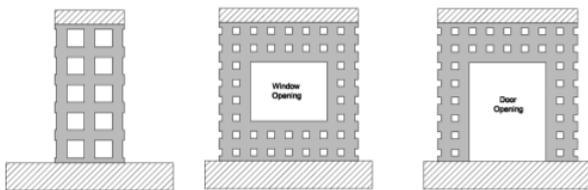
Figure 1 Concrete Core

The tested SGICF walls had different layouts as shown in Fig. 1. Wall dimensions were based on the dimensions given in the PCA report [2]. The overall wall dimensions without

the EPS panels were 2000mm in height, 1000mm in width and 150mm in thickness. The overall thickness of the walls including the EPS Panel was 400mm. Walls SG1 and SG2 had grid dimensions of 400x400mm and consisted of 4 horizontal standard cores, 2 horizontal end cores and 3 vertical standard cores. Standard cores were cylinders of 150mm diameter and end cores were half cylinders. SW1 and SW2 had grid dimension of 250x250mm and consisted of 4 horizontal standard cores, 2 horizontal end cores and 4 vertical standard cores. SD1 and SD2 had grid dimension of 250x250mm and consisted of 2 horizontal standard cores, 1 horizontal end cores and 4 vertical standard cores as shown in Fig. 1. SG1 and SG2 consisted of 1 ϕ 12 bar in each vertical and horizontal core strand. SW1, SW2, SD1 and SD2 consist of 1 ϕ 8 bar in each vertical and horizontal core strand.

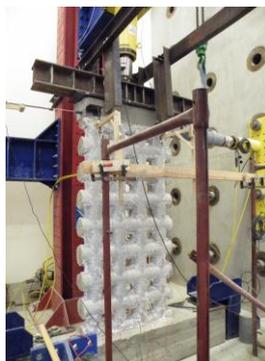
Figure 2 Test Setup

Fig. 2 shows the test setup. The vertical actuator for applying the vertical load was mounted on the steel testing rig while the horizontal actuator for applying the horizontal load was mounted on the lab's strong wall. The foundation beam of the wall assembly was attached to the strong floor using Z-shaped steel assembly as shown in Fig. 2. This supporting arrangement provided the required restraint against the horizontal movement in the direction of the lateral load and uplift from the floor. To achieve uniform vertical load distribution on the wall, the vertical actuator and load cell applied the vertical load on a steel beam supported on five steel rollers spaced equally along the length of the wall. Four steel C channels were fixed on the steel cross beams to restrict out of plane movement of the specimen.

Three LVDTs were placed; two of them to measure the vertical displacement due to uplift and one for the horizontal displacement at the top of the panel.

2. The wall was transported and placed at the testing rig and the foundation beam was fixed to the lab floor by the Z support. Vertical and horizontal actuators were fixed to the testing frame and lab strong wall respectively. The steel top beam and the steel rollers were placed on the top beam. Out of plane restraints were fixed in place. LVDTs and load cells were connected to the data logging system.

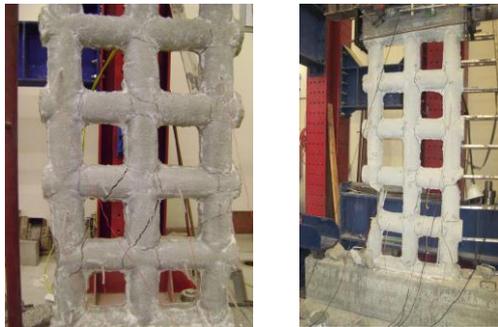
Figure 3 SG1 (left) and SG2 (right)

SG1 is the wall specimen with a wide grid where the spacing between center to center of the vertical and horizontal core strands is 400 mm instead of 250 mm spacing in other specimens with openings. Fig. 3 illustrates the types of cracks in the wall; it shows that flexure and shear cracks developed after applying the lateral load and the wall finally failed in shear.

The illustrated cracking pattern in Fig. 3 indicates that the wall with wide grid spacing behaved more like a multi-story multi-bay frame rather than a shear wall. The positive moment, Fig. 3, at the connections between the columns (vertical strands) and the beams (horizontal strands) caused the developed cracks between these two elements as shown in Fig. 3. Also, the applied shear on the columns and beams of the frame (vertical and horizontal strands) resulted in the observed diagonal cracks. The diagonal cracks occurred in the vertical strand at level above the dowels since below this level the reinforcement is doubled due to the overlap between the dowels and the strands' reinforcing bars.

Specimen SG2 withstood increased cyclic displacement up to 52mm, remaining intact with little damage. When the cyclic displacement value increased to 76 mm the vertical core on the left side completely collapsed as illustrated in Fig. 3. The load displacement curve in Fig. 4 shows the hysteresis loops through cyclic loading. The maximum load the specimen could withstand was 70.4 kN and the maximum displacement was 52mm.

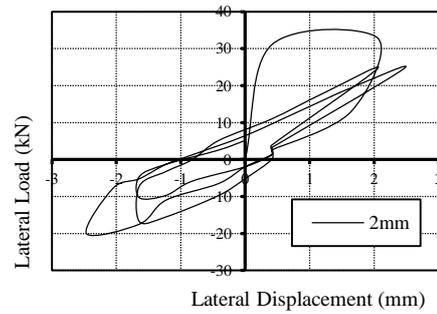
Figure 5 First 3 cycles of SG2

As stated earlier, reversed cyclic loading results in stiffness degradation and this is very clear when observing the load displacement curve of the first 3 cycles. Fig. 5 shows that stiffness of the specimen in the first half cycle was greater than the following cycles. This could be attributed to the minor cracks that were not visible and started to develop at the 2mm displacement level resulting in stiffness degradation.

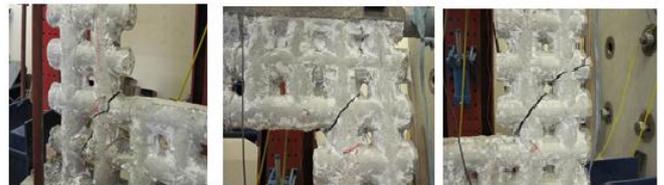
Figure 4 Cracking of SW1, lower left corner (left), upper top corner (center), lower right corner (right)

Specimen SW1 had a window opening. The cracks initiated at the top right corners (the side of lateral load application) and at the bottom left corner of the window as shown in Fig. 6. Wall SW1 failed at lateral load of 89 kN due to shear without reaching the crushing strain of concrete. With the wide window opening, the specimen behaved more like a closed frame consisting of the part on top of the window, the two sides on the left and right of the window, and the part under the window. The closed frame is supported along the entire wall width on the supporting foundation beam. Accordingly, at any load level the assumed frame would be subjected to axial, shear, and bending moment.

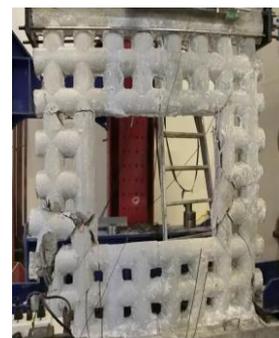
Figure 5 SW2 after cyclic loading

Specimen SW2 withstood displacement up to 23 mm while standing intact. When the displacement value increased to 34 mm the vertical core on the left side completely collapsed as illustrated in Fig. 7 and the vertical steel bars buckled. During one of the cycles of displacement value 15mm the horizontal LVDT moved suddenly out of its position. The test was stopped, and the 3 cycles of displacement level 15 mm were repeated. For this reason, the load-displacement curve has discrepancies. The maximum load the specimen could take was 83.7 kN and the maximum displacement was 23mm.

Upon observing both Fig. 7 and Fig. 8 of the cracks and the load-displacement curve, it can be comprehended that up till the displacement level of 6.75 mm the wall was to a certain extent maintaining its strength and stiffness. Starting the displacement level of 10mm a drastic decrease in strength and stiffness occurred.

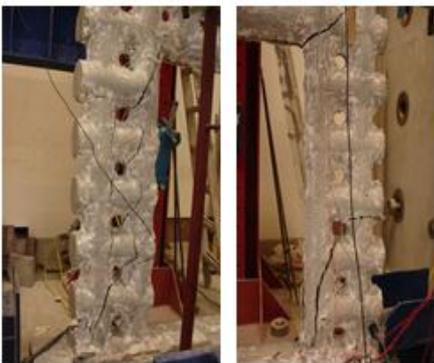
Figure 7 SD1 after applying monotonic load

Specimen SD1 had a door opening. Like specimen SW1 the cracks initiated at the top right corner of the door. Cracks also developed later at the other corner of the door. A major crack was developed over the dowels of the wall at the right of the opening and then propagated diagonally. Diagonal cracks were also observed in the wall on the other side of the opening as shown in Fig. 9. Wall SD1 failed at lateral load of 90.4 kN due to diagonal shear without reaching the crushing strain of the concrete. This wall behaved more like a frame, like SW1, fixed at the foundation beam.

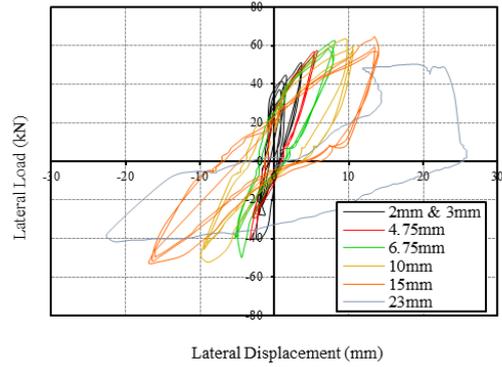
Figure 10 Load- displacement curve of SD2

Specimen SD2 withstood displacement up to 15 mm, Fig. 10, while standing intact. When the displacement value increased to 23 mm the steel and the concrete of the vertical core strand on the left side completely collapsed as illustrated in Fig. 11 and the vertical steel bars buckled. The maximum load the specimen could take was 64.6 kN and the maximum displacement was 23mm.

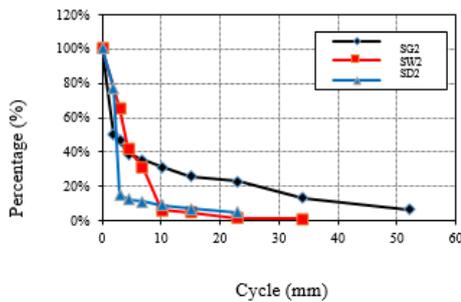
Figure 8 Stiffness Degradation under Cyclic Loading

Concrete members undergo strength and stiffness degradation due to cracking during the reversed seismic loading. A measure of the percentage stiffness degradation of the 3 specimens is plotted in Fig. 12. SG2 is not comparable with SW2 and SD2 due to the different grid size as well as the different aspect ratio. However, when comparing SW2 to SD2, it shows that the degradation of SW2 is smoother than that of SD2. This indicates that the larger the opening the faster the wall loses its stiffness.

4. The results also showed that the stiffness degradation of the wall with door opening (SD2) is more rapid than that of the wall with window opening of the same length (SW2).
