# Causes of Filtration the Water in Roller Compacted Concrete Dams (RCC)

[J. O. Morandi, R. J. Uliarte, A. E. Carmona.]

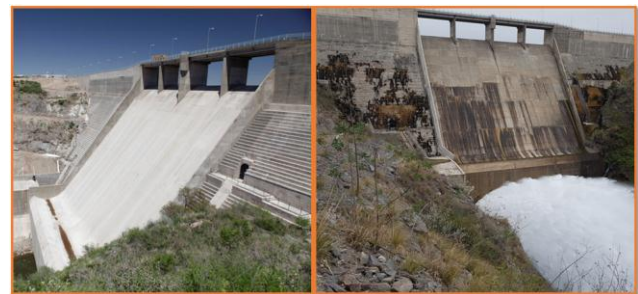
Figure 1. Photos. The dam presents the day of the inauguration, and five years later. There is upwelling of water on the wall waters down by leaks

The Figure 1 and 2 shows the exterior and interior state of the dam.

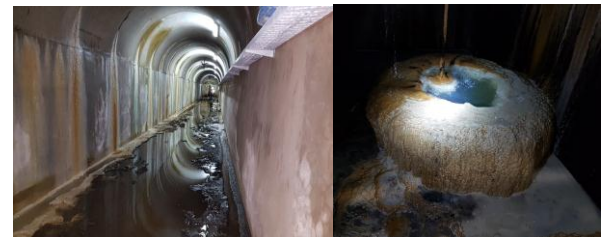
through the body of the dam.

Figure 2. Photos. The interior of the dam is shown. Left a gallery of inspection and the inverted pendulum of auscultation system right. There is large amount of deposits of hydroxide of calcium leached from the body of the dam.

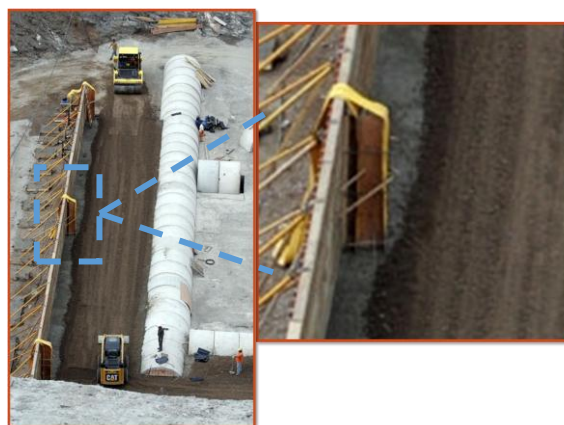
Defect of anchorage of the Joint Water-Stop. It is produced by a failure on the anchor of the Board with the HCV which also it is not compacted properly

Figure 4. Photos. Shows the lack of detail in the placement of the gasket water-stop.

- d. It is advisable to adjust, control and properly certify the proper placement, anchoring and sealing joints water-stop.
- e. Defects in concrete contacts with the rock of the Stirrups, also facilitate the flow of water, can seriously compromise the safety of the dam.

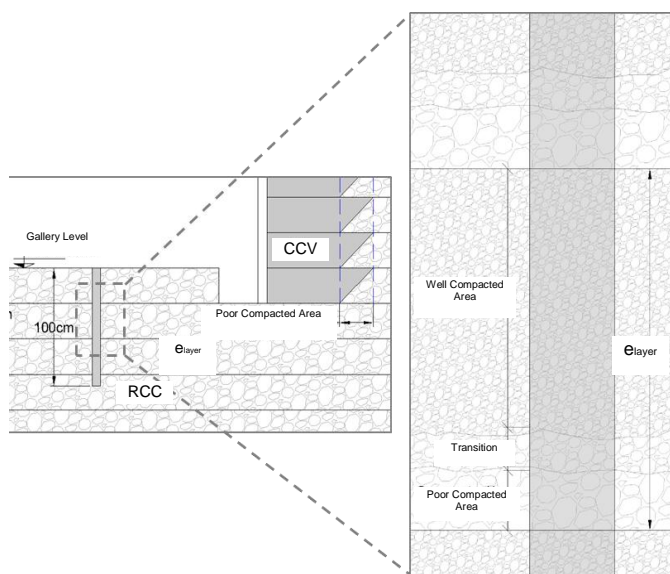
Defect of compaction in RCC layers. If the capacity of the equipment of compaction is not appropriate, stratification occurs in the RCC layer. The bottom of the layer is less dense or with higher porosity that the top layer.

Figure 5. Photos se muestra un esquema de la estratificación en el grado de compactación del RCC.

It establishes a network of flow complex in the body of the dam water that passes the Paramento is defective compaction zones (contact RCC-CCV- Figure3) longitudinally and transversely to the same through the area of compaction defective in RCC layers and horizontal joints between layers (Figure 5).

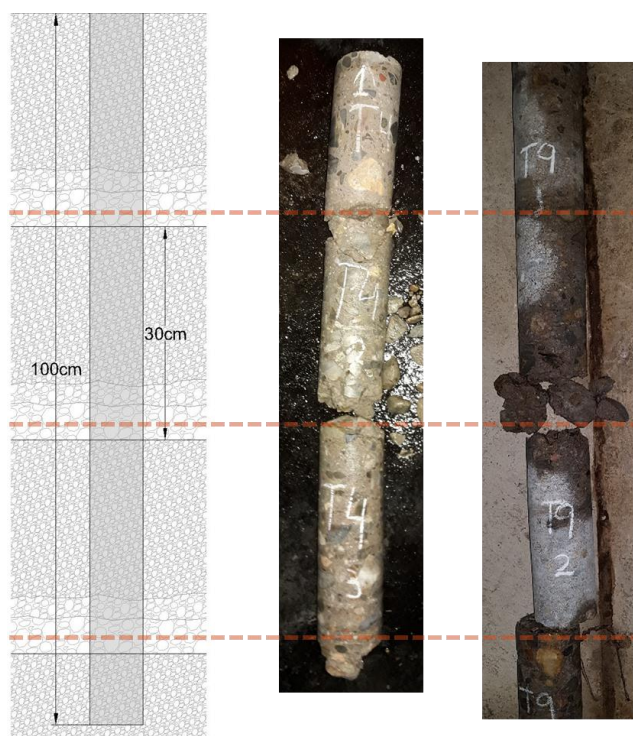
Figure 6. Photos of openwork witnesses on which you can see stratification in the degree of compactation of the RCC.

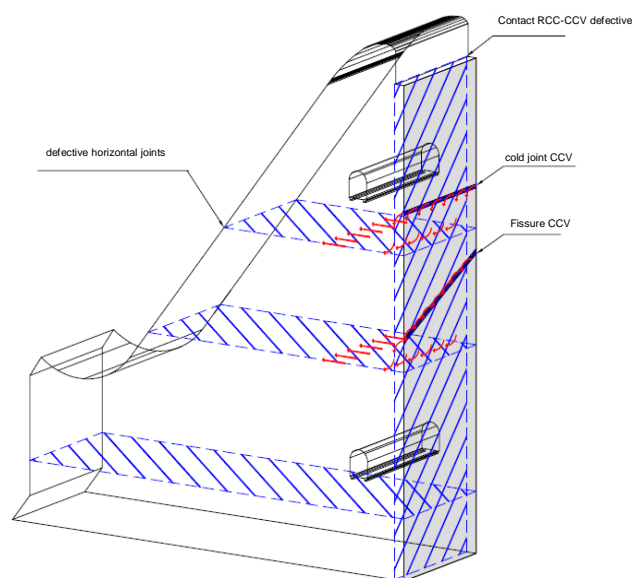
The origin of the leaks is due to the existence of cracks in the wall and defects sealed joints water-stop. A diagram that shows how it is the origin of leaks and its trajectory through the body of the dam is presented in figures 7 and 8.

Figure 7. Se muestra un esquema del ingreso de agua y de la red de flujo través del cuerpo de la presa.

- f. An intervention of the dam with injections of resins of high viscosity is recommended to restore the impermeability of the Paramento.
- g. Also, contacts between RCC and the stirrups of foundation should be injected with grout.

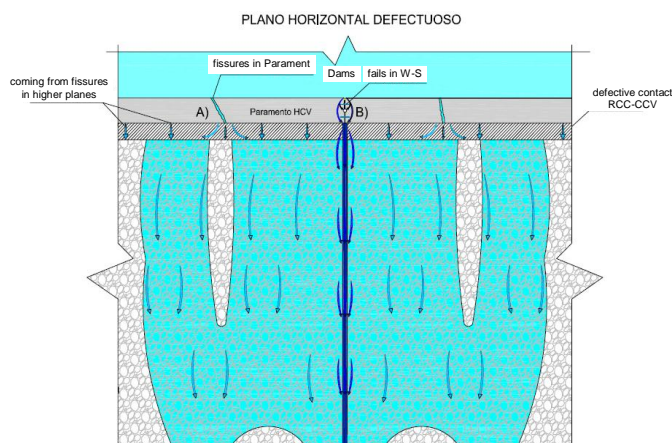
Figure 8. Shows a horizontal section showing the water circulating through the body of the dam and the vertical joints.
