International Journal of Structural Analysis & Design – IJSAD

# BIM in the Maintenance of Buildings

A. Zita Sampaio and Diogo G. Simões

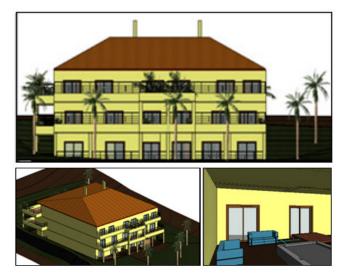
Figure 2. Main façade, general perspective of the model and interior projection of the 3D model.

Some drawings and projections can be obtained from the established model. Figure 1 shows a plan and a cut and Figure 2 illustrates the main facade, a general perspective of the model, and one view shot of the interior.

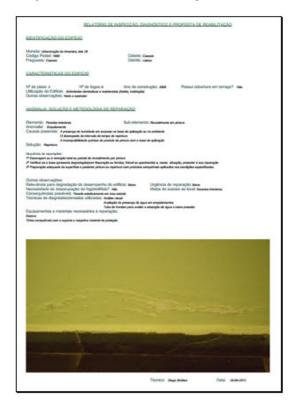
Figure 8. Inspection sheet in pdf format.

The application also allows you to include a photograph of the anomaly taken at the site and convert the information presented in the sheet of inspection to a document in pdfformat. Such possibilities are essential for an inspection sheet, because the addition of a photograph allows the user to recognize the anomaly, its severity and location, and conversion to pdf format enables the user to save the inspection form in *an* universal format. The result of filling the form and its presentation in *pdf*, are illustrated respectively in Figures 7 and 8.

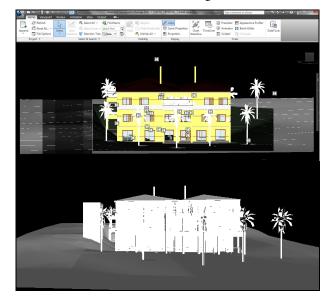
Figure 9. Navisworks interface showing the color deprivation in the IFC format.

The data transfer between the BIM modeler and visualizer, in IFC standard, resulted in complete preservation of information and error free. The only limitations observed were the clutter of information and a lack of storage capacity of the previously predefined colors, which led to the total deprivation of color of the model, as illustrated in Figure 9.

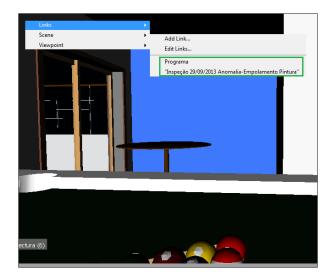
Figure 11. Selection of the inspection sheet of the anomaly associated with the inner wall.

Whilst planning for maintenance operations, or any other inspection activity, the choice of the element in which lies the anomaly (the wall inside the room depicted in blue in Figure 10) identifies two associated attachments: the inspection program and a sheet of the inspection carried out on the 29 Oct. 2013, concerning an anomaly called paint blistering (Figure 11). By choosing the link "Inspection 29 Oct. 2013 - Anomaly- paint blistering", the user is automatically opening the *pdf* document related to the associated inspection form, i.e. the sheet shown in Figure 11.
