# Assessment of Efficiency of Air Abrasive Cleaning on Masonry Stones and Bricks Using Greyscale Imaging Analysis

**Abstract** — Advanced greyscale imaging analysis was conducted using Adobe Photoshop 6 on the surfaces of masonry stones and clay bricks, taken from old buildings, to accurately assess the efficiency of building cleaning. Five commonly used masonry stones and clay bricks for those buildings were selected, and seven abrasives were adopted for air abrasive (sandblasting) cleaning. Also the reductions in thickness were continuously monitored for assessing the cleaning efficiency. The cleaning degree at different stages was assessed using greyscale image photos, converted from original colour ones, together with reductions in thickness. In general, greyscale continuously increased with the cleaning time and tended to be stable when the surface became fully cleaned. Thickness reduction monotonically increased with the cleaning time. The most efficient building cleaning case would be the one with the shortest cleaning time and smallest thickness reduction. The harder abrasives with smaller particles sizes were confirmed to be more effective.

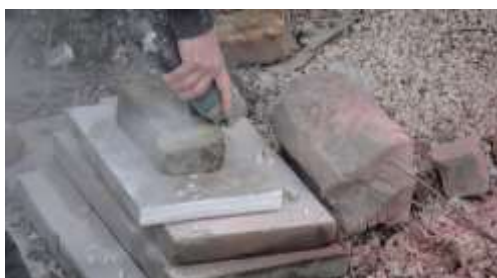
Figure 1. Cutting samples from original stones and bricks.

All five masonry stones and clay bricks were selected from those for masonry buildings and exposed to environmental conditions for decades with large amounts of soiling and decay on the façades. The samples were cut into the sizes of 50 mm × 50 mm × 25 mm from the original masonry stones and bricks using a diamond saw (see Fig. 1). The exposed surfaces of the samples were then cleaned to different degrees with each abrasive in turn. The cleaning system included an air compressor, shot blasting cabinet and nozzle (see Fig. 2). Fig. 3 shows all five masonry stone and clay brick samples.

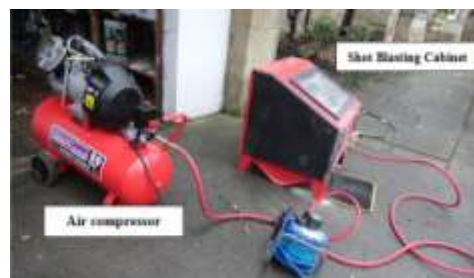
Figure 2. The abrasive cleaning system.

Air abrasive cleaning (sandblasting) involves a stream of compressed air directing particles of abrasive materials onto the soiled masonry surfaces. Here, cleaning is accomplished by these particles dislodging the surface layer and the dirt adhering to it. The dislodging of the dirt deposits thus takes place by the breaking up, sometimes to a depth of several millimetres, the surface layer beneath the deposits. Both dry and wet blasting methods have similar effects on cleaning masonry façades. The abrasive cleaning does not differentiate between removing soiling and masonry, and the effect of jetting the abrasive material is controlled by the operator. When wrongly applied, it could have a long lasting damaging effect on the building façade. Abrasive cleaning is a quick method and is therefore usually considered for large areas of metals or masonries which have few design features. The most commonly used system is the air pressure blast equipment. Typical nozzle pressures range from 0.02 kPa to 14.0 kPa.

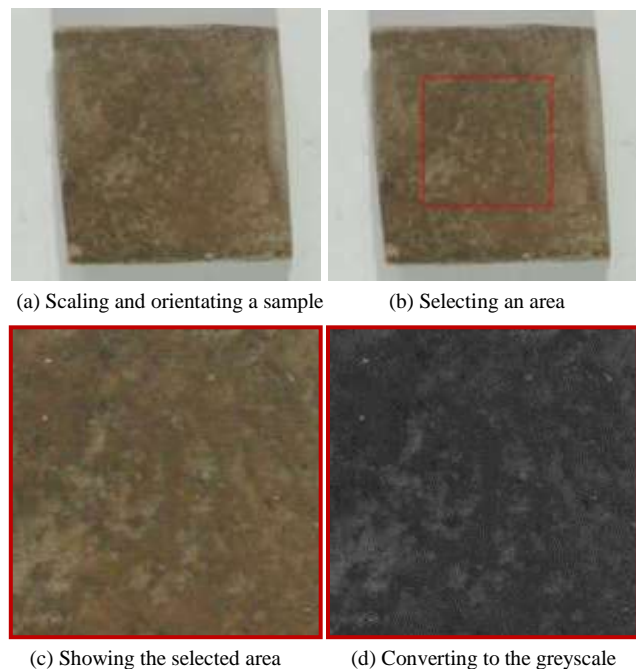
Figure 6. Four steps for processing an image photo for red sandstone cleaned with fine glass.

Since not all the samples had the same dimensions, their central areas of  $20 \text{ mm} \times 20 \text{ mm}$  were used for the greyscale imaging analysis. This standardisation of the area would allow all the images to be compared. There would be four separate

steps next. The original images were scaled and orientated. An area inside was selected by drawing a red frame on the image, which was then cropped. Finally, the cropped area was converted into the greyscale image. Fig. 6 shows a typical example of this procedure, which was then applied to all the images of 35 stone samples at different cleaning stages.

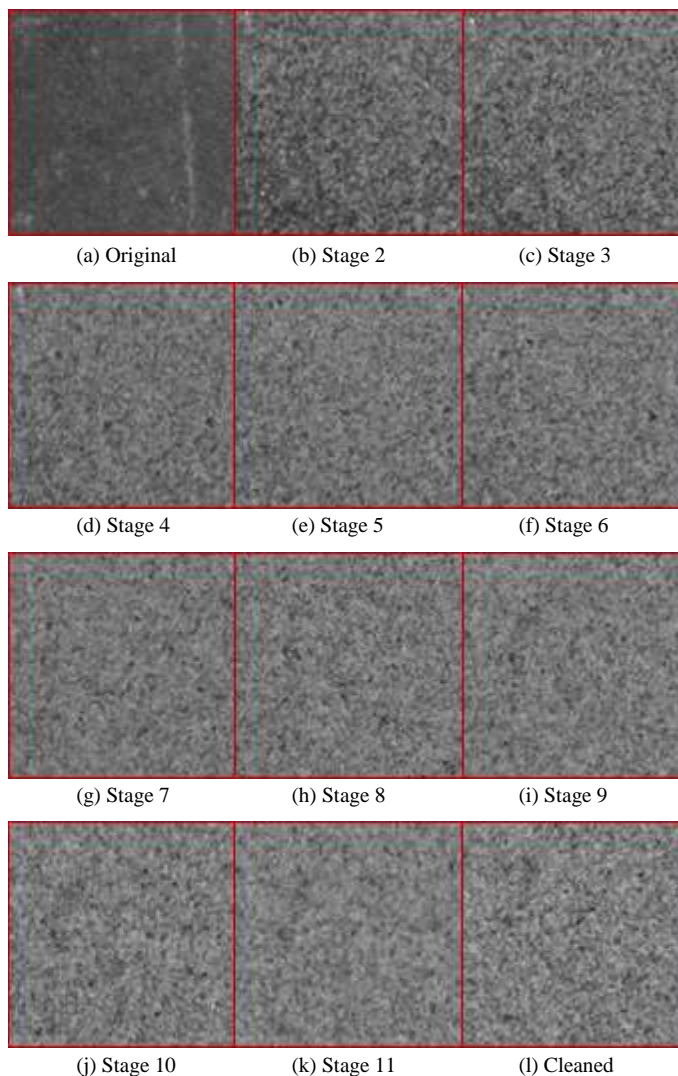
Figure 8. Greyscale images of yellow sandstone cleaned with coarse slag at cleaning stages 1 to 12.

Figs. 7 to 11 show the greyscale images of all masonry stone and brick samples cleaned with slag or glass abrasives at different cleaning stages. In these photos, the first images show the original dirty surfaces and the last photos show the fully cleaned surfaces. From each image the average greyscale value and standard deviation were obtained using Adobe Photoshop 6. All five sets of greyscale images indicate that the masonry surfaces became gradually brighter with cleaning except yellow clay brick which sustained reverse trends.

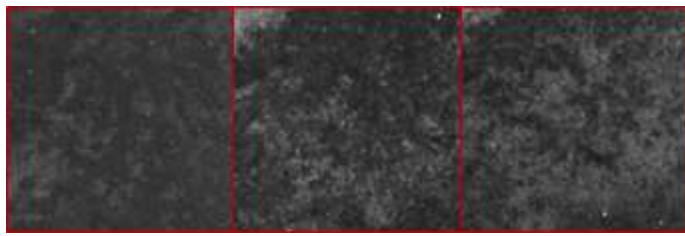
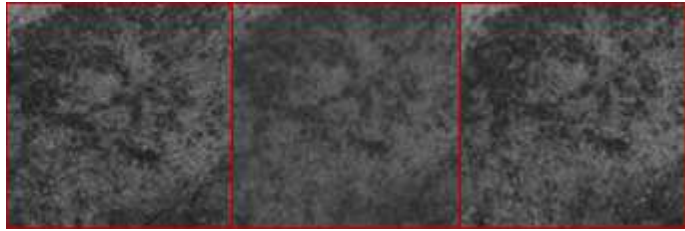
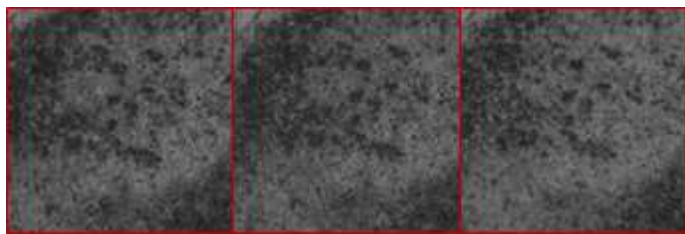
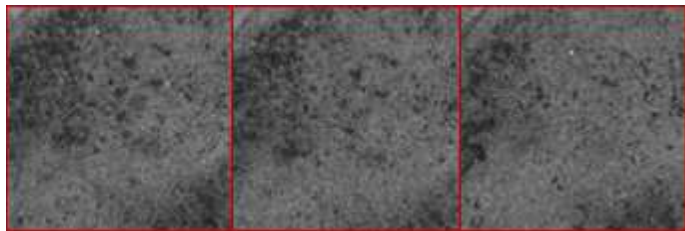
Figure 9. Greyscale images of red sandstone cleaned with fine glass at cleaning stages 1 to 12.

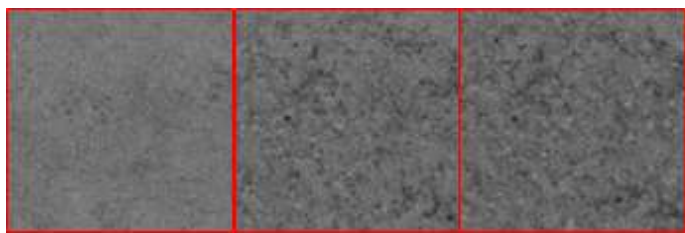
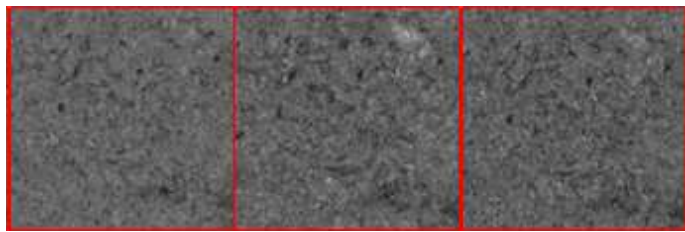
Figure 10. Greyscale images of yellow clay brick cleaned with medium glass at cleaning stages 1 to 6.

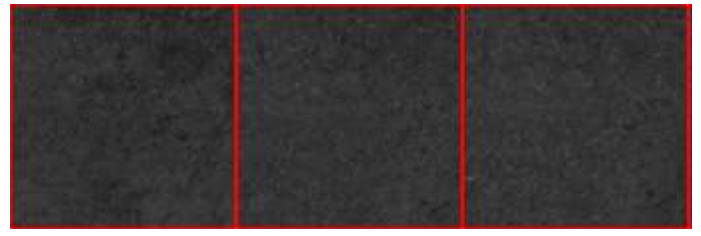
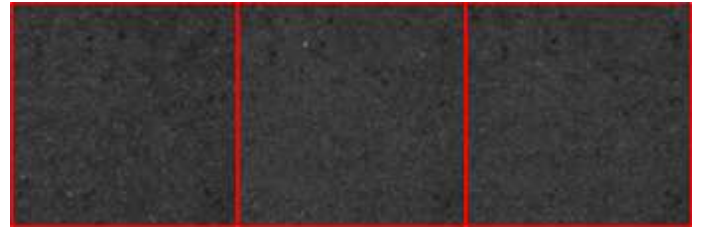
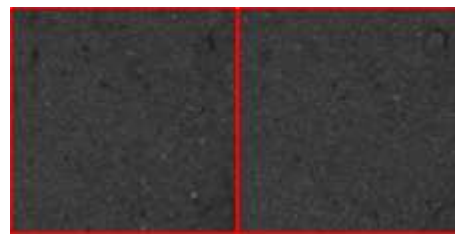
Figure 11. Greyscale images of red clay brick cleaned with medium glass at cleaning stages 1 to 8.

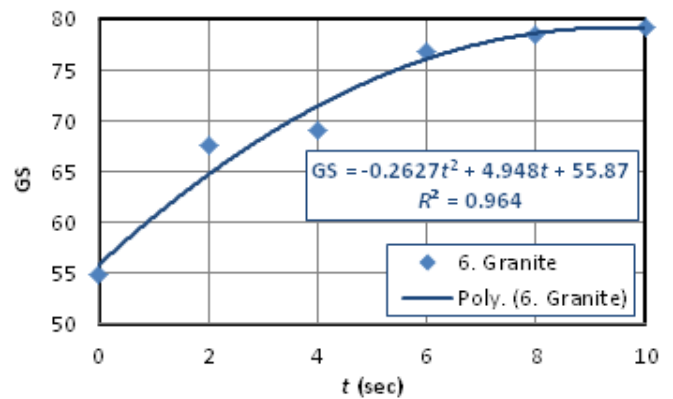
Figure 12. Greyscale versus cleaning time for granite cleaned with fine glass.

Figs. 12 to 16 show the relationships between the greyscale GS and the cleaning time  $t$  for the five masonry stones and clay bricks. Fig. 12 indicates that a parabola well reflects the increasing trend of greyscale with the cleaning time for granite cleaned with fine glass. The data and the parabola almost coincide since the  $R^2$ -value is equal to 0.964 which is very close to 1.0. Greyscale increased with the cleaning time from  $GS = 54.83$  before cleaning at a decreasing rate and became stable at  $GS = 79.24$  when the sample was fully cleaned after 10 seconds, up by 24.41 in GS or 44.5%. It seems that only 6 seconds corresponding to  $GS = 76.80$  may be enough to largely clean this sample. The gap in greyscale values between the original dirty and fully cleaned states was quite big, which indicates that the surface of the original granite was very dirty.

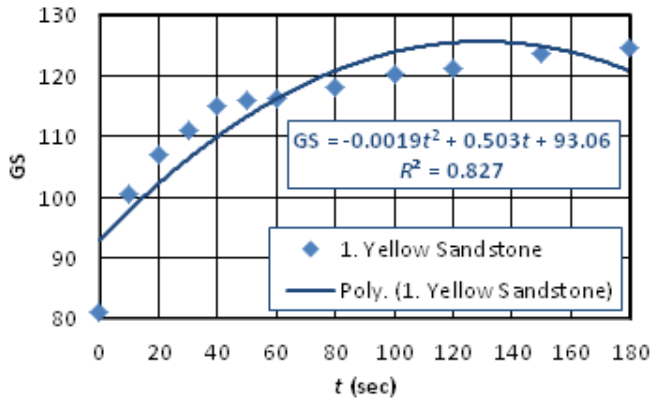
Figure 13. Greyscale versus cleaning time for yellow sandstone cleaned with coarse slag.

Fig. 13 shows that a parabola can represent the increasing trend of greyscale with the cleaning time for yellow sandstone cleaned with coarse slag, with  $R^2 = 0.827$ . Greyscale increased with the cleaning time from  $GS = 81.14$  before cleaning at a decreasing rate and finally became stable at  $GS = 124.51$  when the sample was fully cleaned after 180 seconds, up by 43.37 in GS or 53.5%. It seems that it would take about 100 seconds, for  $GS = 120.23$ , to almost fully clean this sample. The gap in greyscale values between the original dirty and fully cleaned states was reasonably large, which indicates that the surface of the original yellow sandstone was quite dirty.

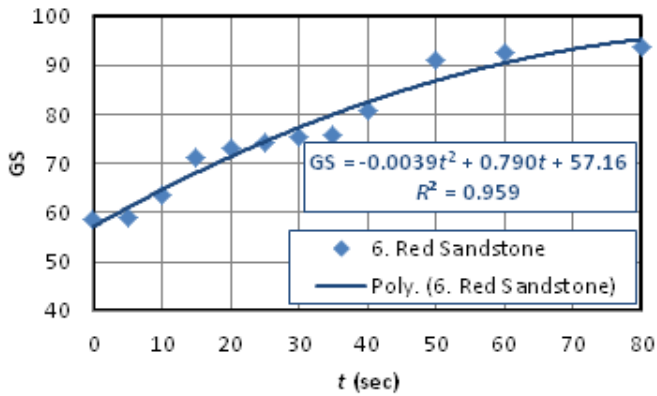
Figure 14. Greyscale versus cleaning time for red sandstone cleaned with fine glass.

Fig. 14 shows that a parabola well matches the increasing trend of greyscale with the cleaning time for red sandstone cleaned with fine glass. The data and the parabola almost

coincide with  $R^2 = 0.959$ . Greyscale increased with the cleaning time from  $GS = 58.56$  before cleaning at a decreasing rate and finally became stable at  $GS = 93.84$  when the sample was fully cleaned after 80 seconds, up by 35.28 or 60.2%. It seems that 50 seconds, corresponding to  $GS = 90.94$ , may be enough for almost fully cleaning this sample. The gap in greyscale values between the original dirty and fully cleaned states was huge, indicating that the surface of the original red sandstone was very dirty.

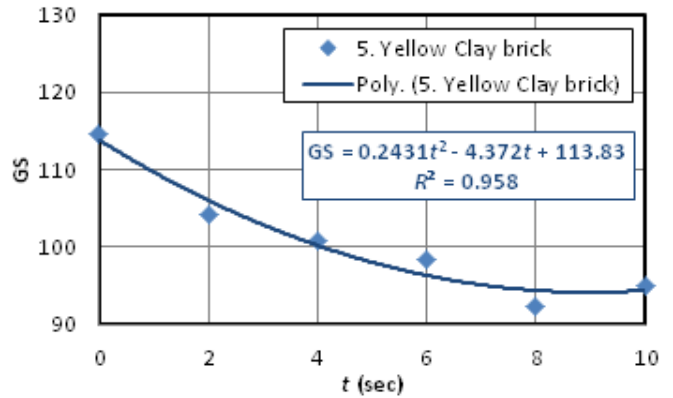
Figure 15. Greyscale versus cleaning time for yellow clay brick cleaned with medium glass.

Fig. 15 shows that a parabola can represent the reverse decreasing trend of greyscale with the cleaning time for yellow clay brick cleaned with medium glass. The data and the parabola almost coincide with  $R^2 = 0.958$ . Greyscale decreased with the cleaning time from  $GS = 114.60$  before cleaning at a decreasing rate and finally became stable at  $GS = 94.96$  when the sample was fully cleaned after 10 seconds, down by 19.24 in  $GS$  or 16.8%. It seems that only 6 seconds corresponding to  $GS = 98.36$  may be enough for almost fully cleaning this sample. The gap in greyscale values between the original dirty and fully cleaned states was not quite big, which indicates that the surface of the original yellow clay brick was not very dirty.

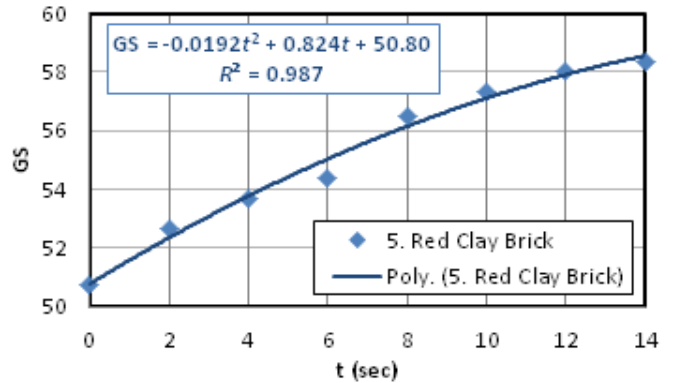
Figure 16. Greyscale versus cleaning time for red clay brick cleaned with medium glass.

Finally, Fig. 16 shows that a parabola well reflects the increasing trend of greyscale with the cleaning time for red clay brick cleaned with medium glass as well. The data and the parabola almost coincide with  $R^2 = 0.987$ . Greyscale

increased with the cleaning time from  $GS = 50.74$  before cleaning at a decreasing rate and finally became stable at  $GS = 58.38$  when the sample was fully cleaned after 14 seconds, up by 7.64 in  $GS$  or 15.1%. It seems that it would take about 10 seconds, corresponding to  $GS = 57.33$ , to almost fully clean this sample. The gap in greyscale values between the original dirty and fully cleaned states was also small, indicating that the surface of the original red clay brick was not very dirty.
